PRELIMINARY IMPACT ASSESSMENT REPORT:

Grounding of the *Shen Neng 1* on Douglas Shoal

30 July 2010

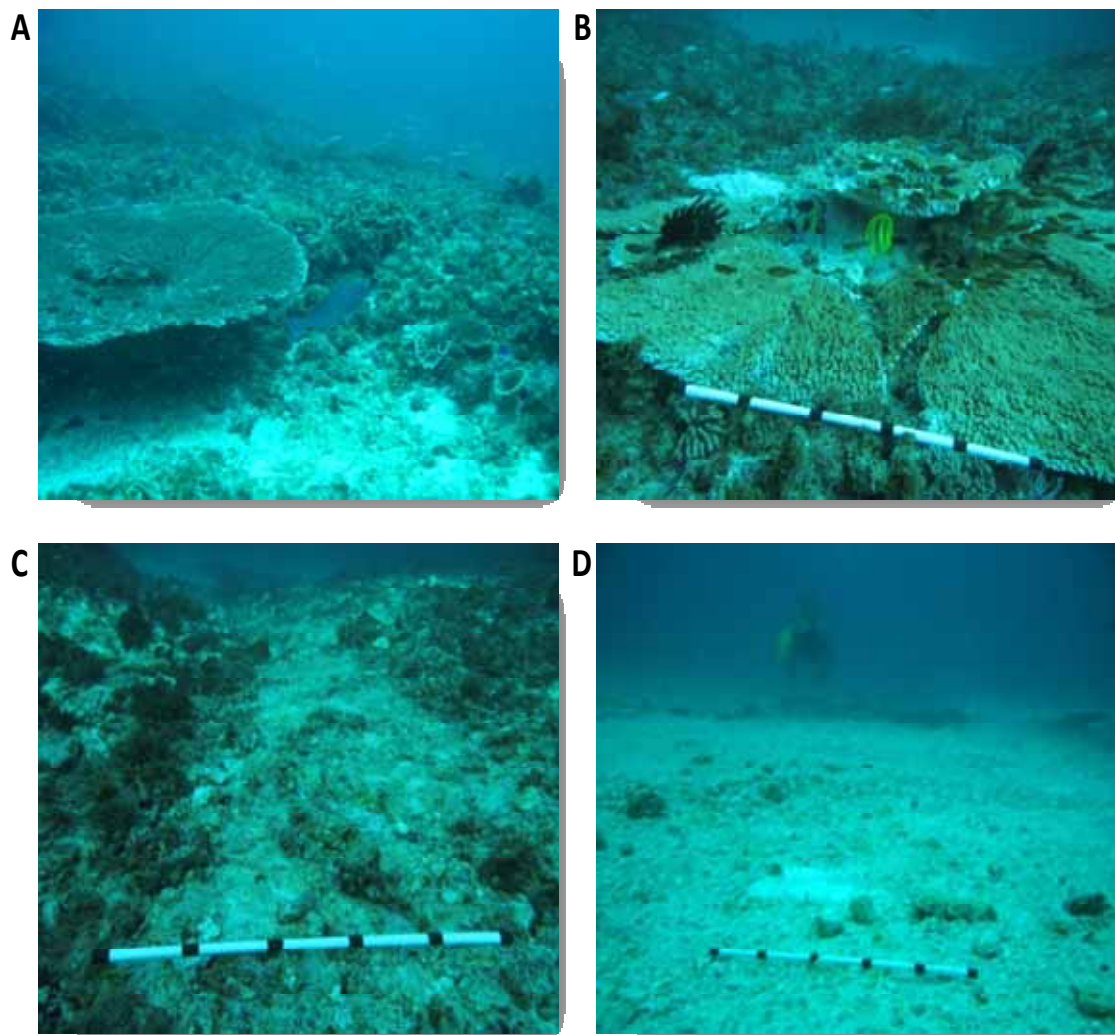
- Severe damage : *all benthos¹ displaced, crushed or smothered and substrate scraped or covered in rubble*
- Moderate damage: *most benthos killed; patchy damage to substrate*
- Minor damage: *most benthos intact; some damaged*

Figure 3. Images from Douglas Shoal after *Sheng Neng 1* grounding showing the different categories of damage. (A) Undamaged reef; (B) Minor damage (most benthos intact; some damaged); (C) Moderate damage (most benthos killed; patchy damage to substrate); (D) Severe damage (all benthos displaced, crushed or smothered and substrate scraped or covered in rubble). Scale bar = 50 cm.

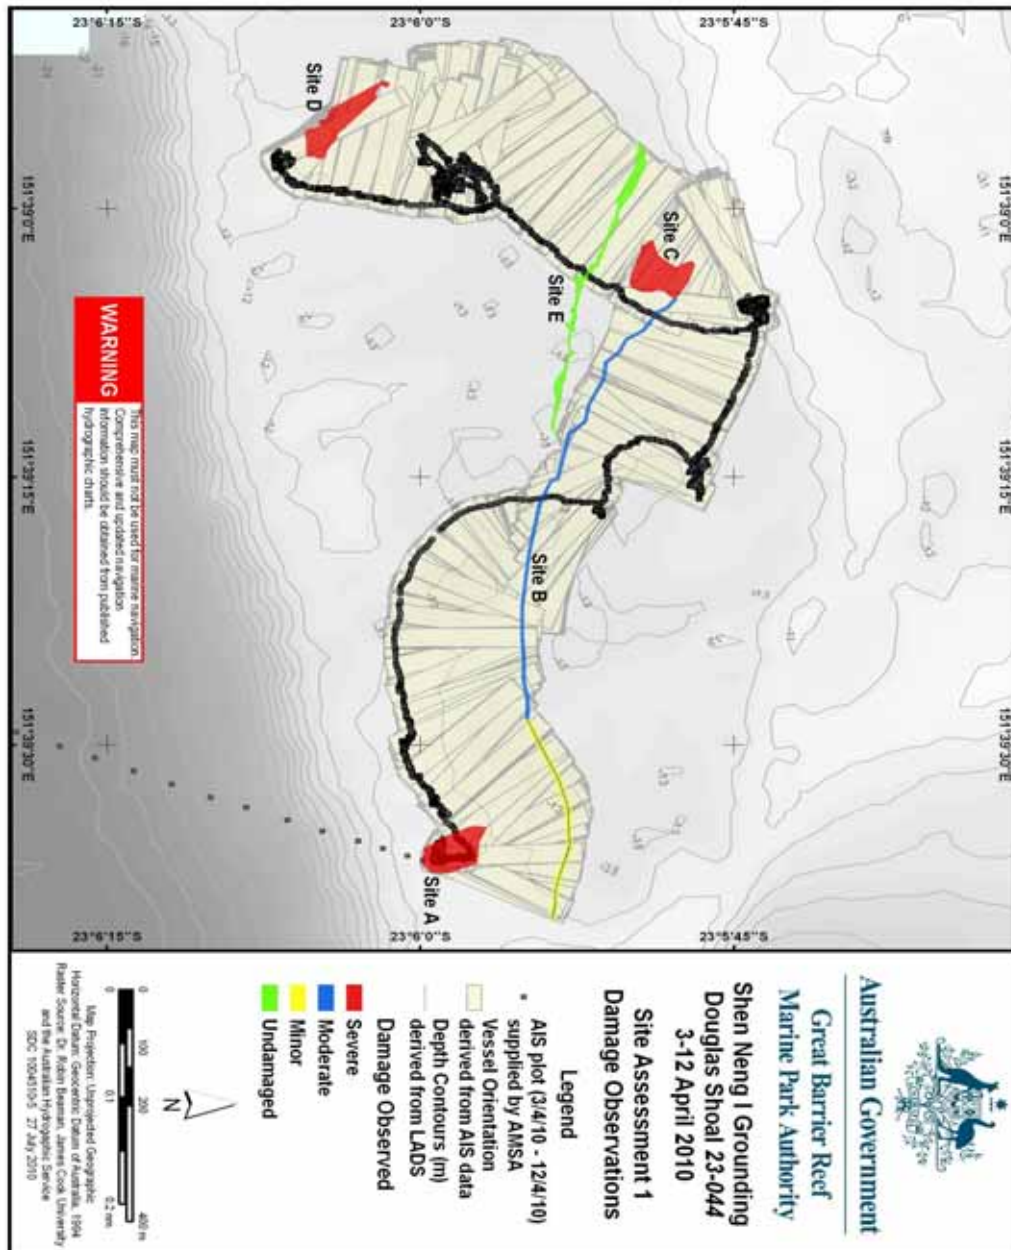
Figure 5. Locations of the sites inspected during the Preliminary Impact Assessment at Douglas Shoal, showing categories of damage observed against backdrop of vessel positions.

The survey team identified areas of recent ecological damage at four locations on the shoal (marked as Sites A, B, C and D on Figure 5). Sites A, C and D were characterised by broad areas of severe damage. Site B was a long, narrow tract of moderate damage. The severity of damage can be seen in the photographs and video footage recorded during the survey and in representative photos presented in Figures 3 and 4. A more detailed description of observations at each site is provided below. Table 1 provides a summary of the estimated size of damaged areas at each site.

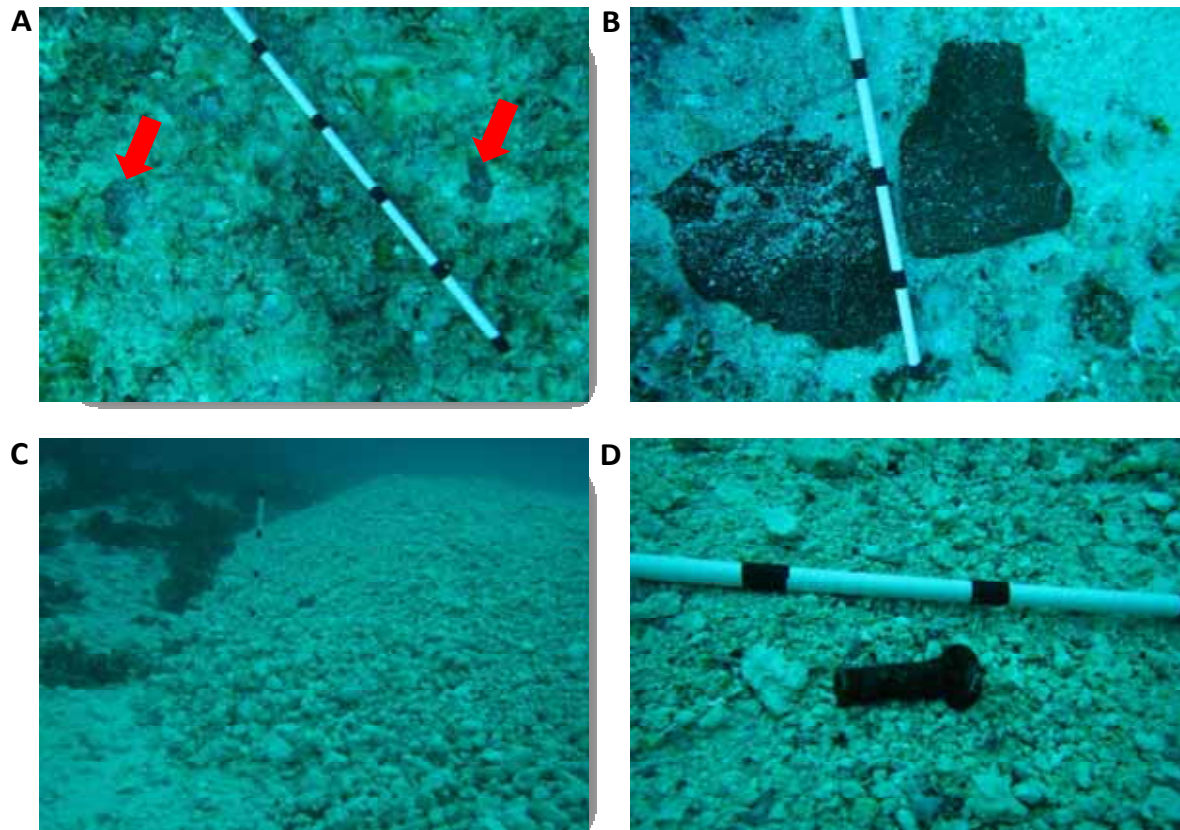
Figure 4. Photographs from damaged areas of Douglas Shoal. (A) Antifoulant paint smears (red arrows) on moderately damaged site (Site A); (B) Large metal flakes on moderately damaged reef site (Site B); (C) Recently created rubble bank on edge of severely damaged site (Site D); (D) Metal bolt on severely damaged seabed (Site D). White sections on scale bar = 8 cm.

Some areas of reef in Sites A and D were clearly exposed to contamination from antifoulant paint, as evident from visible flakes of paint amongst the rubble or smears of paint on the exposed reef substrate (Figure 4).

Signs of freshly deposited antifoulant paint were observed at three of the damage sites inspected. Visible flakes of paint were observed among the crushed coral substrate at Sites A, C and D, and antifoulant paint was seen smeared onto the exposed reef substrate at Site A. Antifoulant paints are designed to inhibit settlement by larvae of sessile marine organisms, including algae, ascidians, sponges, molluscs and corals. They are also known to be toxic to adult reef organisms, such as corals (Smith et al. 2003). The presence of antifoulant chemicals at a ship grounding site can prevent or slow recolonisation of damaged areas, and also has the potential to cause additional stress or mortality to corals not damaged by direct physical impacts (Haynes et al. 2002; Marshall et al. 2002).
