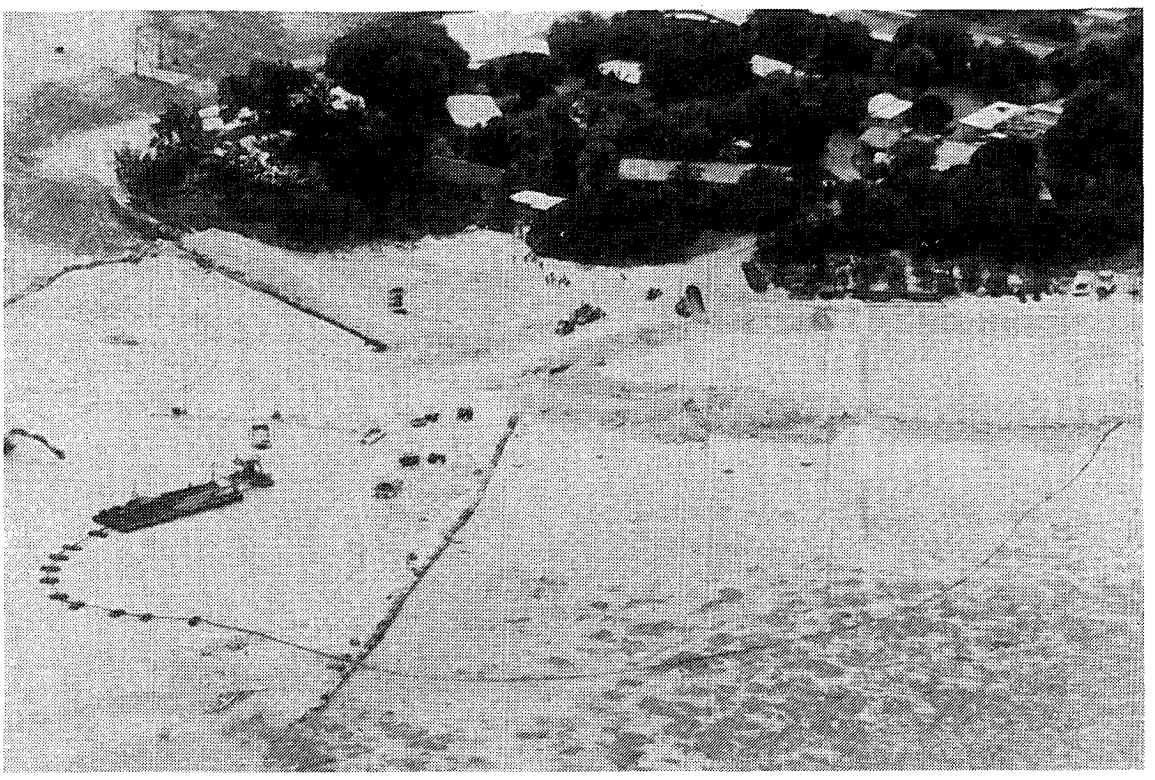
Photo 1. Aerial view of boat harbour and spoil dump during construction - 6 October 1987. (Photo QNPWS)
