PRELIMINARY IMPACT ASSESSMENT REPORT:

Grounding of the *Shen Neng 1* on Douglas Shoal

30 July 2010

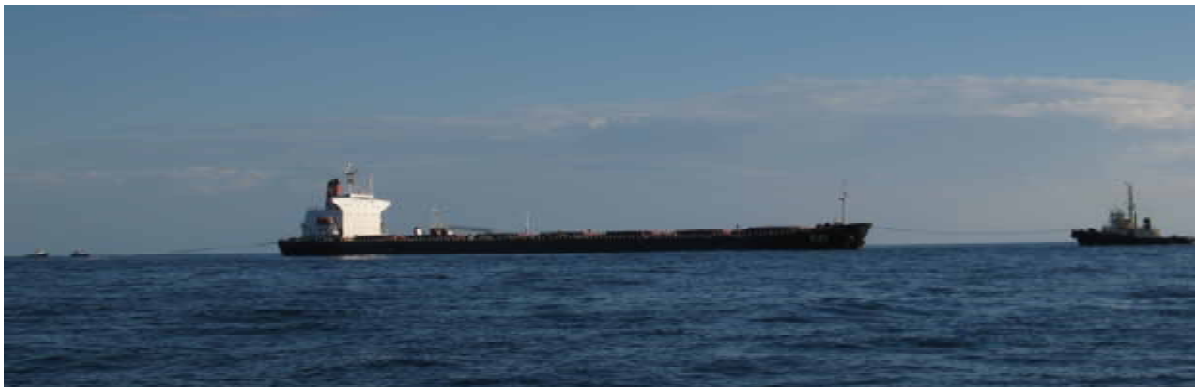
The cargo carrier *Shen Neng 1* ran aground on Douglas Shoal (Figure 1), around 92km north-east of Gladstone, on Saturday 3 April 2010. After transfer of some of the oil on board the *Shen Neng 1* to a bunker barge, salvage specialists assessed the ship as safe for refloating and transport. At approximately 8pm on Monday 12 April the *Shen Neng 1* was removed from its position on Douglas Shoal.

Figure 1. *Shen Neng 1* over Douglas Shoal on the southern Great Barrier Reef.

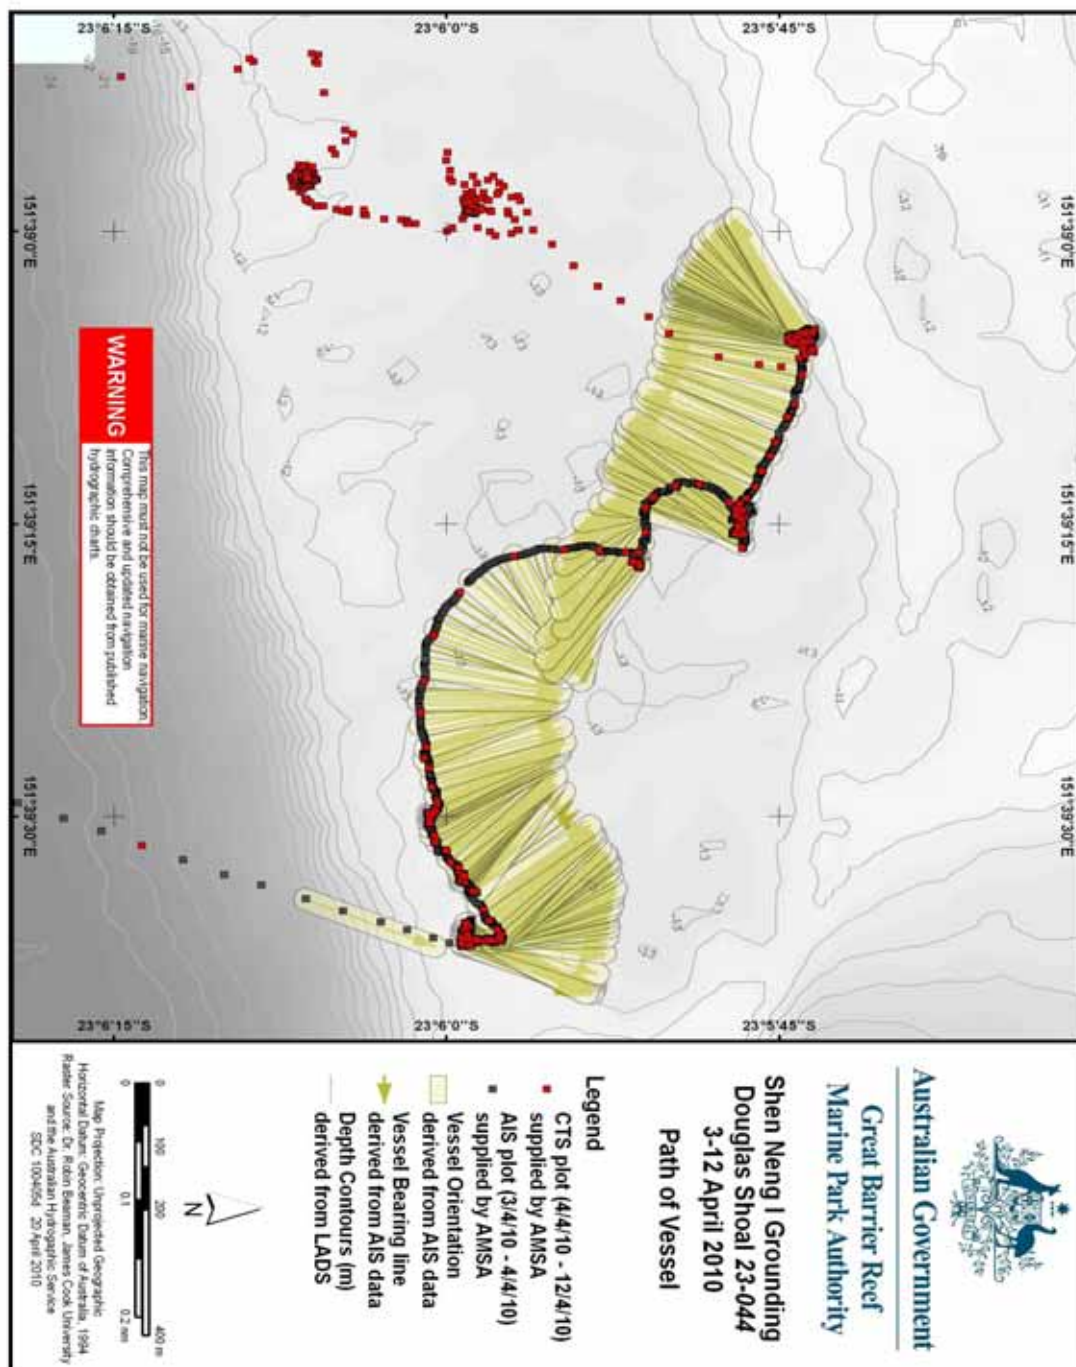
Figure 2. Map provided for preliminary assessment by GBRMPA's Spatial Data Centre. The map is plot of the location of the Shen Neng 1 over Douglas Shoal, based on information provided by the Australian Maritime Safety Authority.

Areas of Douglas Shoal where there was the greatest potential for damage from the grounding of the *Shen Neng 1* were identified from a map of the position of the vessel while over the shoal (Figure 2). This map was generated by the Great Barrier Reef Marine Park Authority's Spatial Data Centre using coordinates of the vessel's position supplied by the Australian Maritime Safety Authority (AMSA).
